DEPARTMENT OF TRANSPORTATION

Contract #: 04-0120F4Cty: SF/ALA Rte: 80 PM: 13.2/13.9File #: 99.28**WELDING INSPECTION REPORT****Resident Engineer:**Pursell, Gary**Address:** 333 Burma Road**City:** Oakland, CA 94607**Report No:** WIR-016471**Date Inspected:** 28-Aug-2010**Project Name:** SAS Superstructure**OSM Arrival Time:** 700**Prime Contractor:** American Bridge/Fluor Enterprises, a JV**OSM Departure Time:** 1900**Contractor:** Zhenhua Port Machinery Company, Ltd (ZPMC)**Location:** Shanghai, China

Orthotropic Box Girder (OBG) at Trial Assembly Areas

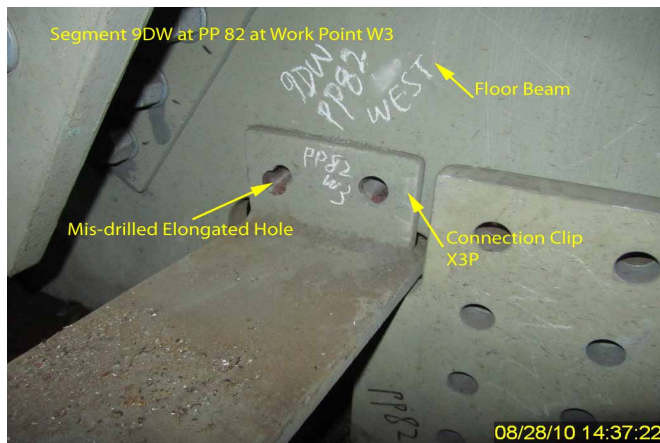
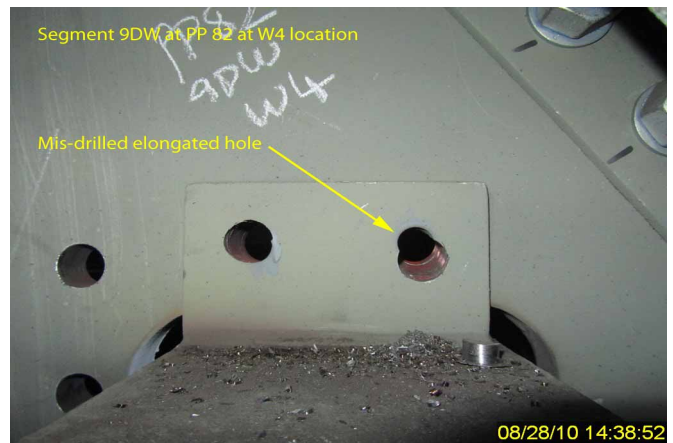
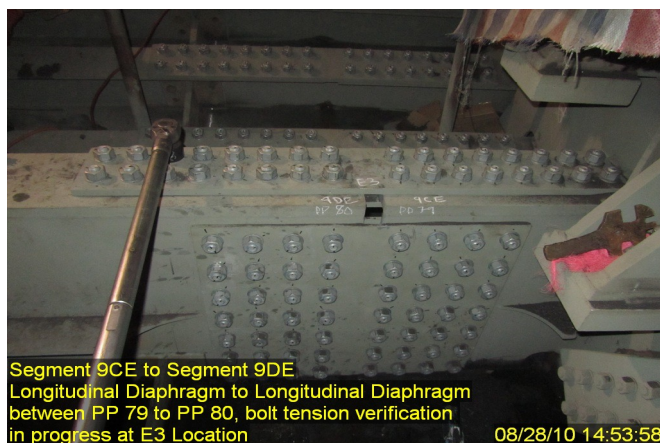
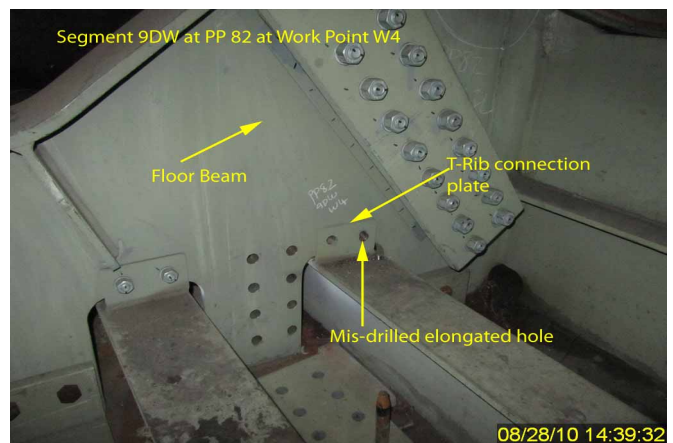
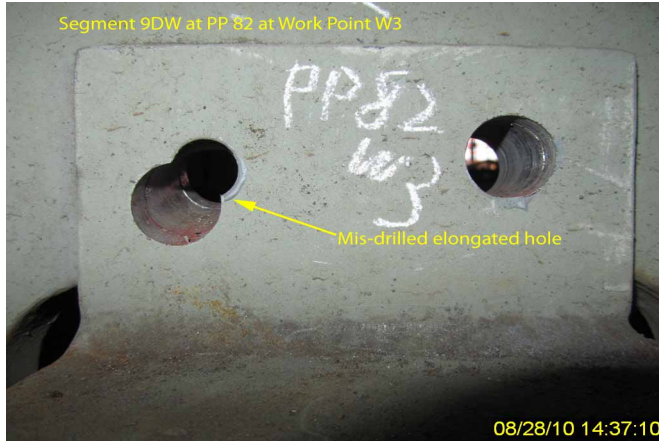
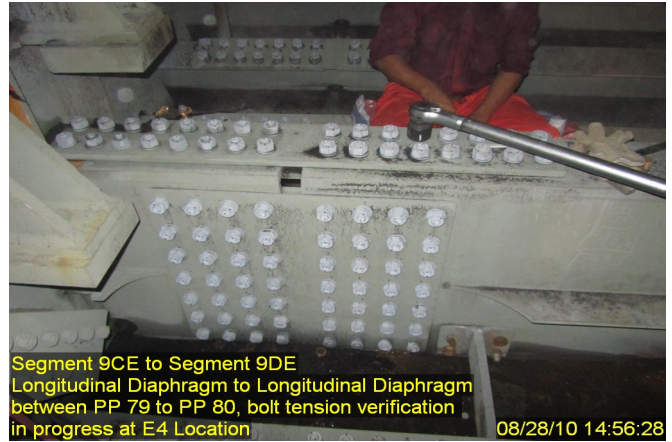
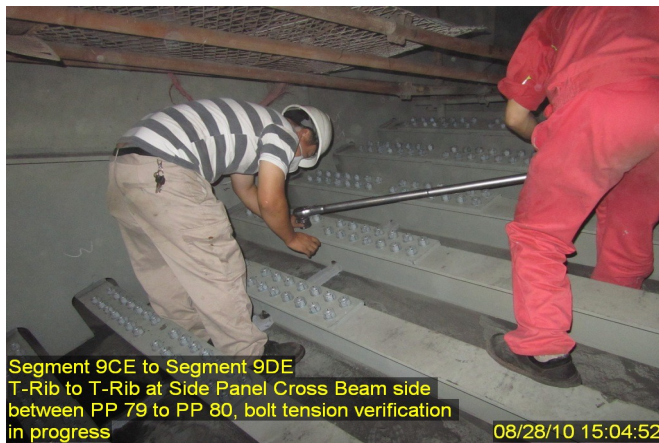
This Quality Assurance (QA) Inspector wrote an Incident Report for improper match drilling holes at Bottom Panel T-Rib connection plate connecting to Floor Beam at Panel Points (PP) 74 and PP 75 for Segment 9BW and at PP 81 and PP 82 for Segment 9DW. Please reference the Incident Report

This QA Inspector witnessed final bolt tension verification on bolts connecting T-Rib to T-Rib for Transverse Splice at Side Panel Bike Path Side (from work point E1 towards E3), Bottom Panel (from work point E3 towards E4) and Cross Beam side (from work point E4 to E6) between Panel Point (PP) 79 to PP 80 for Segment 9CE to

9DE. Inspected the bolt tensioning on a random basis and found the tension to be in general compliance. Inspection was performed against the Notification No. 00466 dated August 28, 2010.

This QA Inspector witnessed the final bolt tension verification on bolts connecting the Longitudinal Diaphragm to Longitudinal Diaphragm between Panel Points (PP) 79 and PP 80 for Segment 9CE to Segment 9DE at work point E4, Cross Beam side and work point E4 Bike Path side. The QA Inspector verified the bolt tension on a random basis and the results appeared to be in general compliance. The Inspection was performed against Notification No. 00466 dated August 28, 2010.

This QA Inspector witnessed the final bolt tension verification on bolts connecting the Cable Tray Structures installed at Bottom Panel T-Ribs at North and South Side between Panel Points (PP) 71.25 to PP 72 and PP 72 to PP 73 for Segment 9AE. The QA Inspector verified the bolt tension on a random basis and the results appeared to be in general compliance. The Inspection was performed against Notification No. 00466 dated August 28, 2010.
